## **Rankin Ridge Lookout Tower, Wind Cave National Park Assessment of Qualification for Listing on National Register of Historic Places**

Mark David Spence, PhD  
27 September 2010

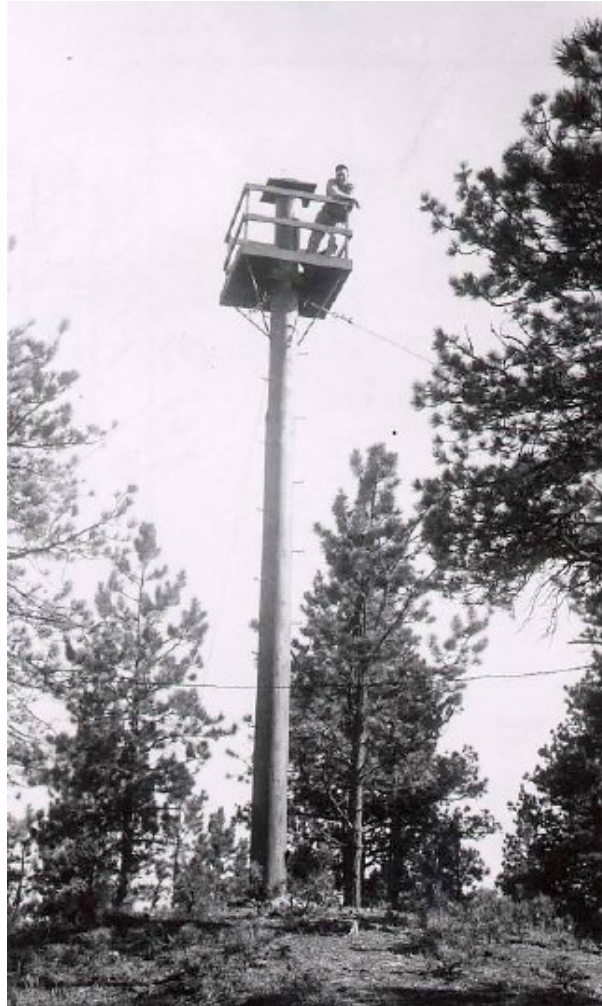
40' Crow's Nest Lookout Tower on Elk Mountain, ca. 1930s.

Superintendent Semingsen had already submitted a proposal to erect a temporary lookout tower on Rankin Ridge until a more permanent structure could be planned and built. It was determined that the simple lookout tower at Elk Mountain, “a 40 foot cedar pole

surmounted by a crow's nest," would serve this purpose and in July 1952 it was relocated to Rankin Ridge.<sup>7</sup>

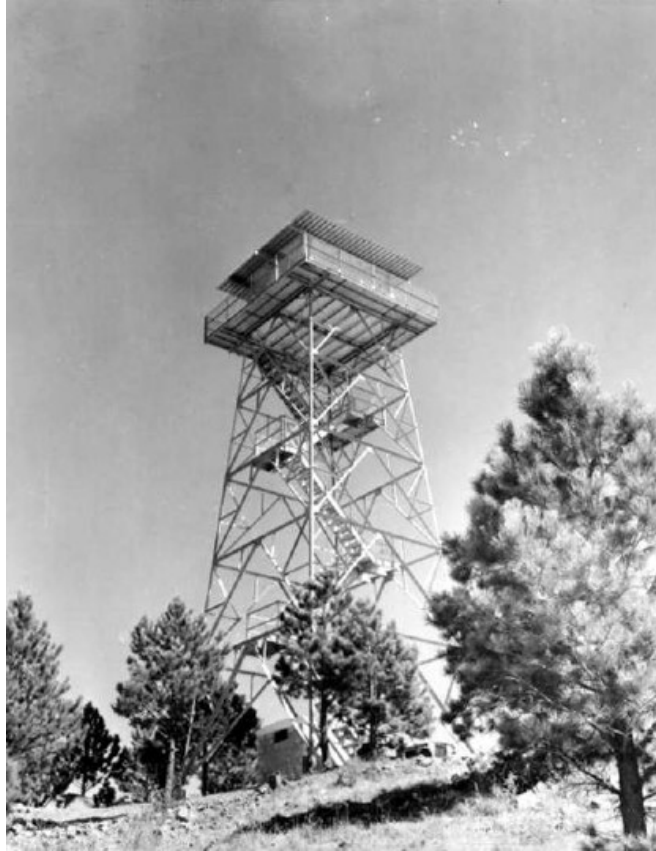
Rankin Ridge Lookout Tower, ca. 1957.  
Source: Wind Cave National Park

As noted above, the structure fabricated by Dresser-IDECO for Wind Cave National Park followed the specifications established for a "U.S. Forest Service, Standard Steel Lookout Tower." Also known as a "CL-100 type," as first delineated in a 1938 Forest Service publication *Standard Lookout Structure Plans*, these towers were initially

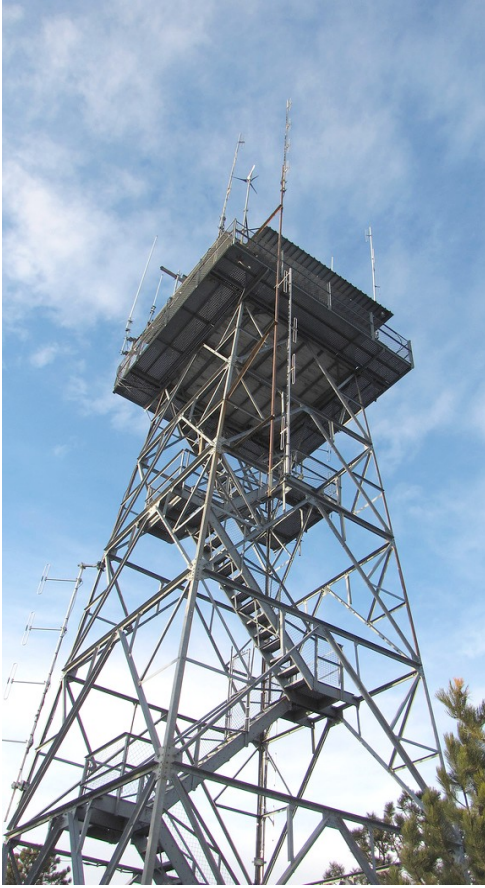
Seth Bullock Lookout Tower,  
Black Hills National Forest (2010)

<sup>19</sup> Phone interview with Dennis Mauch, Black Hills National Forest, Bear Lodge Ranger District, 3 September 2010. Personal visit to Seth Bullock Lookout Tower site, 1 September 2010. Both the Warren Peak and the Seth Bullock Lookout Towers are officially listed at 53 feet. The one-foot difference from the Rankin Ridge Lookout Tower is likely the result of different sized footings.

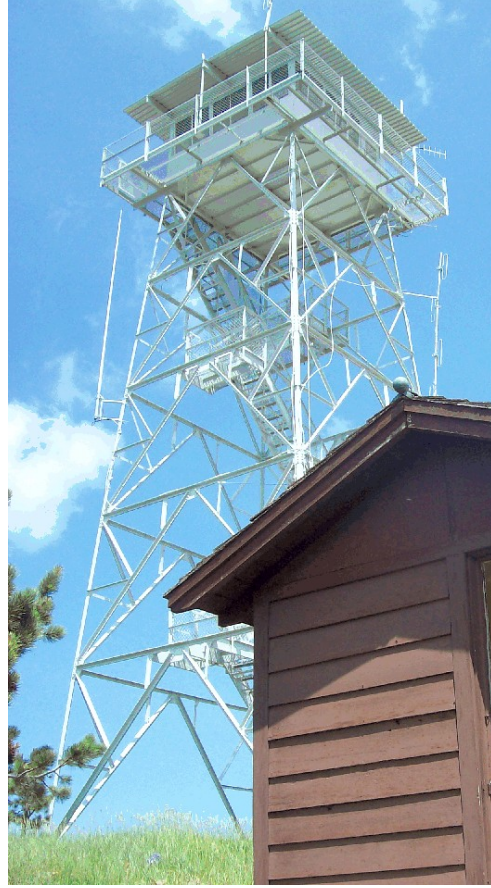
Warren Peak Lookout Tower, Black  
Hills National Forest. Source: USFS
